New spillway provides much-needed water to ranchers and farmers

Lovelock, Nevada

## Rodgers Dam - North Spillway

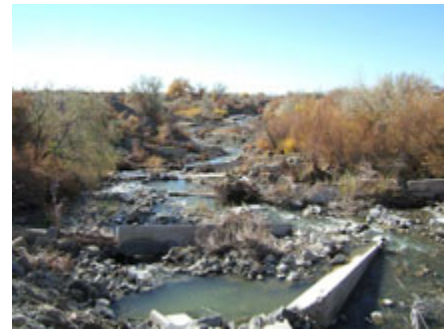
original spillway

Lovelock, Nevada – Rodgers Dam Spillway is located near the end of the 300-mile long Humboldt River, which runs through northern Nevada, and also is the longest river in the United States that does not ultimately reach the ocean. Rodgers Dam is one of the last structures on the river before it empties into the Humboldt Sink. In 2006, due to an unusually wet spring, the river sustained a continuous high rate of flow for three full months and on July 17, the 55-year-old dam failed. All of the water pressure caused the sub grade soil under the structure to give way and the concrete portion of the dam was completely under cut. The water rushed under the dam and through a gap that was five feet high and 80' wide. Luckily, no one was injured and no property damage was reported.

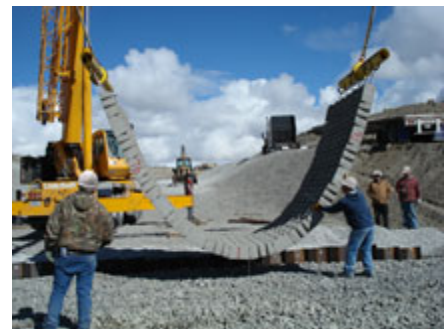
installation of ArmorFlex

CONTECH presented the [ArmorFlex](#) Class 70T, articulating mat option for the spillway. Using a hydraulic engineering center-river analysis system (HEC-RAS) model of the channel provided by DEC, CONTECH value engineered a solution that could withstand the 3000 cubic feet per second (cfs) discharge and handle sub grade settlement without compromising the structure.

A 50' wide concrete structure at the top of the spillway transitions down to a trapezoidal channel 72' wide at the top with a 40' wide bed. It takes water from the upper part of the reservoir and lets it go down 350' to the bottom of the riverbed. Based on the model, the water velocity coming down the spillway is in the 20 ft per second (fps) range which determined the use of 70-T ArmorFlex tapered series. The 24,000 ArmorFlex blocks are installed bank to bank over a geotextile suited for the very fine soil conditions. The 8' wide and 26' long ArmorFlex mats were lifted into place by a crane and set on a prepared sub grade.

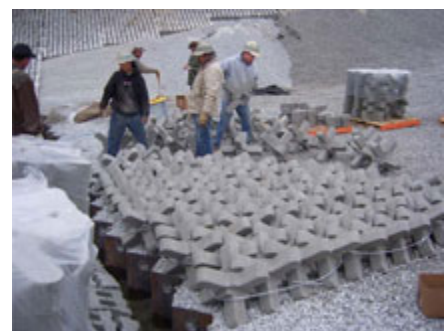
installation of A-Jacks

CONTECH recommended installing 24" [A-Jacks](#) the width of the spillway. The flow comes down the slope over the articulated ArmorFlex Class 70T. The water transitions to the flatter surface where it runs into a 38' long field of A-Jacks forcing a hydraulic

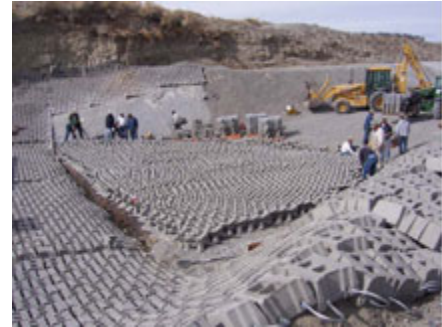
installation of A-Jacks continues

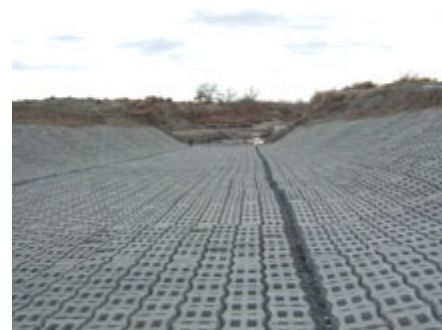
ArmorFlex installation complete

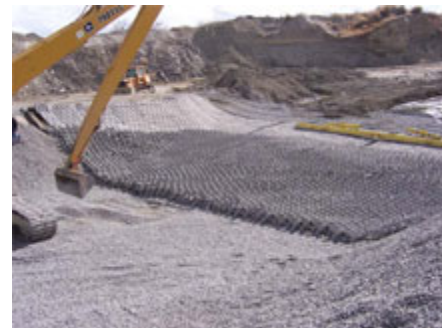
A-Jacks installation complete

jump that brings the water down to a sub critical flow. The water velocity coming into the field of A-Jacks is 20 fps and CONTECH achieved 3 fps on the outlet. The target outlet velocity was 4 to 5 fps.

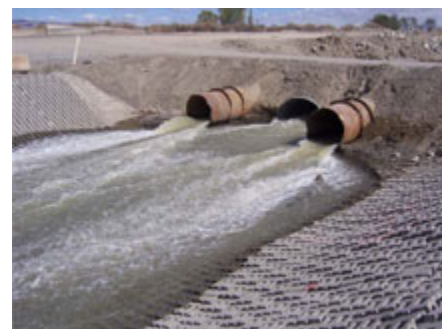
spillway complete

consists of a trapezoidal channel that has a top width of 72 feet, a bottom width of 40 feet, a depth of 10 feet, and a length of approximately 400 feet.

The North spillway is a gravel and clay structure with a gravel fuse plug over the top that serves as a road. Two 54" diameter steel pipes and one 6' diameter arch pipe pass through it. Removable planks installed over the pipe ends control the water flow out of the reservoir to the agricultural land below.

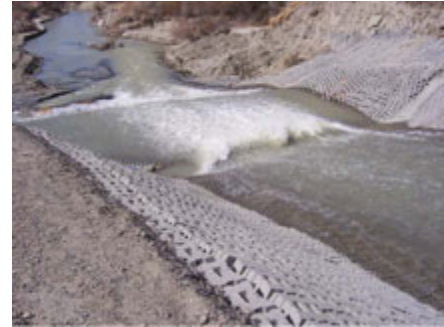
hydraulic jump
